## **Stability of the Ro Wen shingle spit, Fairbourne**

**Graham Hall                  May 2022**

### **Summary**

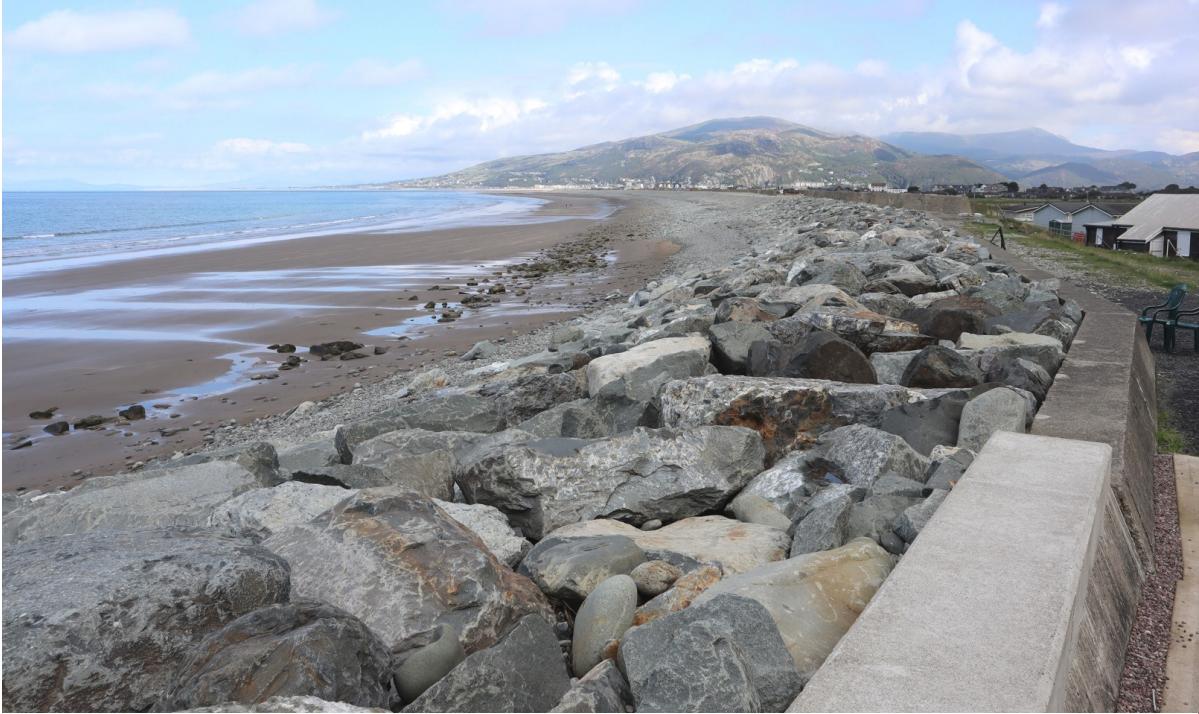
Friog corner, where work has recently been carried out to repair and strengthen the sea defences.

Repairs to the sea wall were carried out by Gwynedd County Council and Natural Resources Wales, including the emplacement of sheet steel piles to prevent water inflow, and the addition of large boulders to dissipate wave energy (see title page illustration). This work has been effective in preventing the inflow of water during subsequent storms, and no further flooding has occurred at Friog.

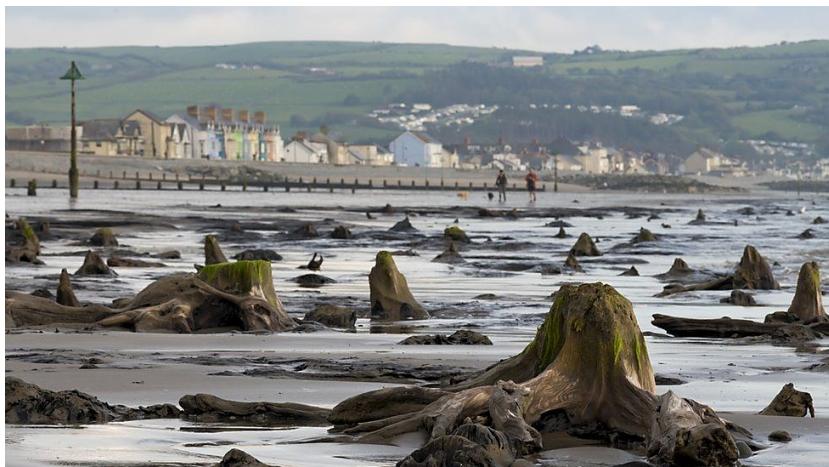
**Figure 5:**

Remains of the submerged forest at Borth, exposed during exceptionally low tides.

A relic of the former coastal plain can be seen at very low tides in Borth, where remnants of a former forest are exposed (fig.5)

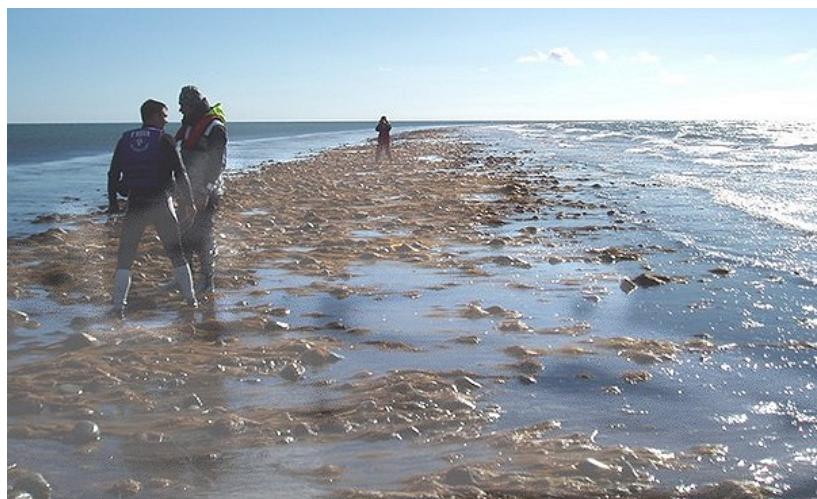
**Figure 8:**

Sarn Badrig moraine, exposed off the coast of Harlech during very low tides.

The first is rock material picked up by storm waves from shallow off-shore moraine deposits. This is similar to the coarse pebbles making up the sarns which extend into Cardigan Bay and are exposed at very low tides (fig.8). Originally deposited by glaciers, this material has now been reworked and sorted by waves and currents.

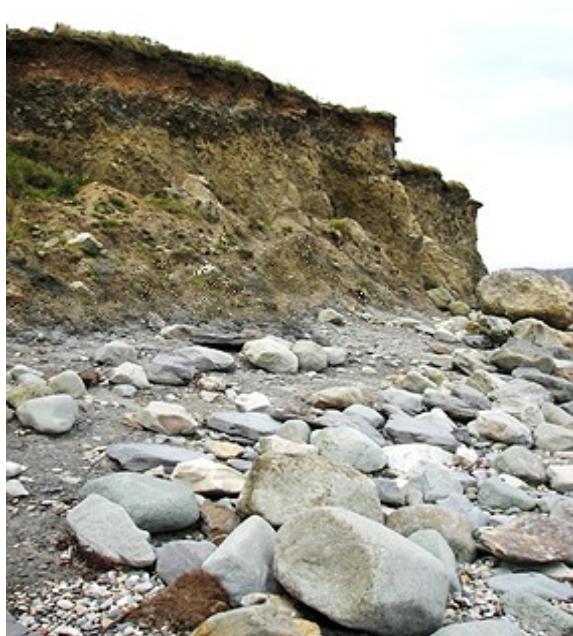
**Figure 9:**

Glacial deposits in the cliffs at Llwyngwrl.

A second source of pebbles is from the erosion of soft boulder clay cliffs, which extend southwards from Fairbourne along the coast between Llwyngwrl (fig.9) and Tonfannau.

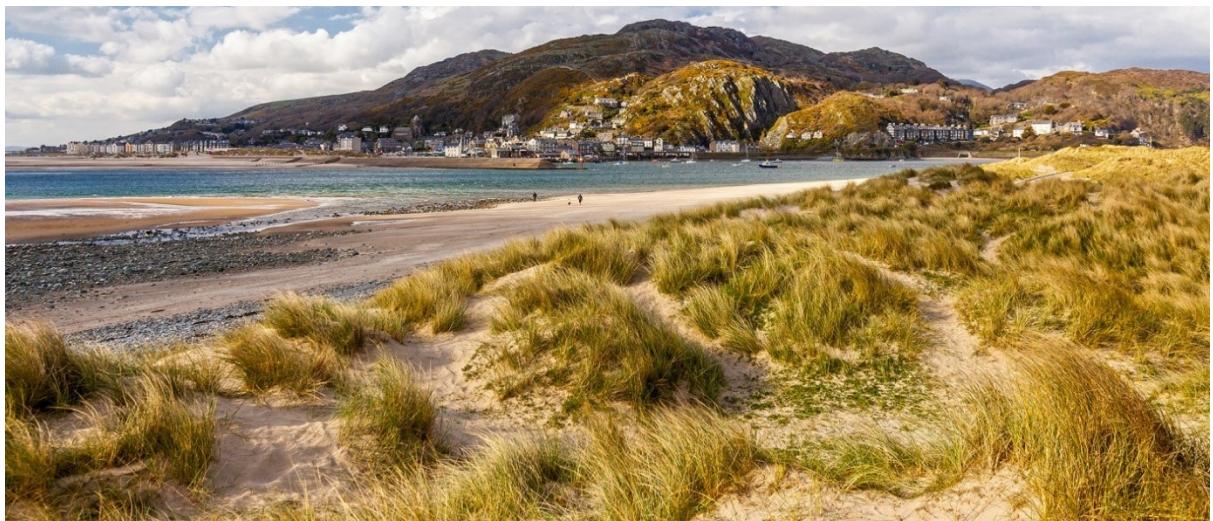
**Figure 10:** Sand dunes produced by windblown sand from the foreshore deposited above the shingle storm beach towards the northern end of the Ro Wen spit.

Fig.10 shows the Ro Wen spit as it approaches the mouth of the Mawddach estuary. At this point, the shingle bank is covered by sand dunes, produced as dry sand is blown inland from the foreshore at low tide by the prevailing south-westerly winds.

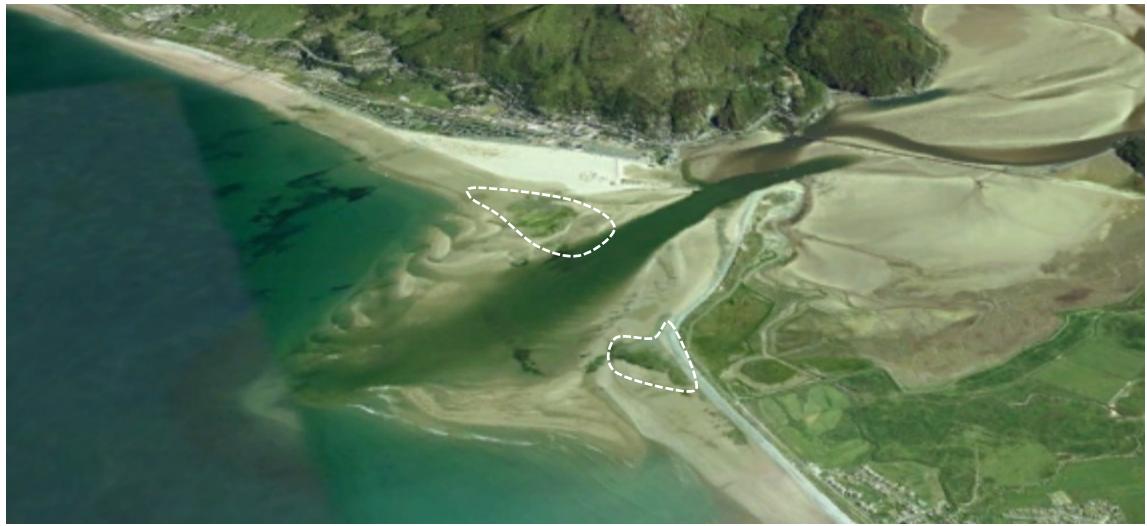
**Figure 12:** Intertidal deposits at the mouth of the Mawddach estuary. Remnants of the Mawddach moraine are indicated by dotted outlines.

It appears that the Ro Wen spit developed northwards from Friog cliff until the moraine remnant was reached. Further development of the spit has occurred at an angle caused by the movement of shingle into the estuary mouth during rising flood tides (fig.12).

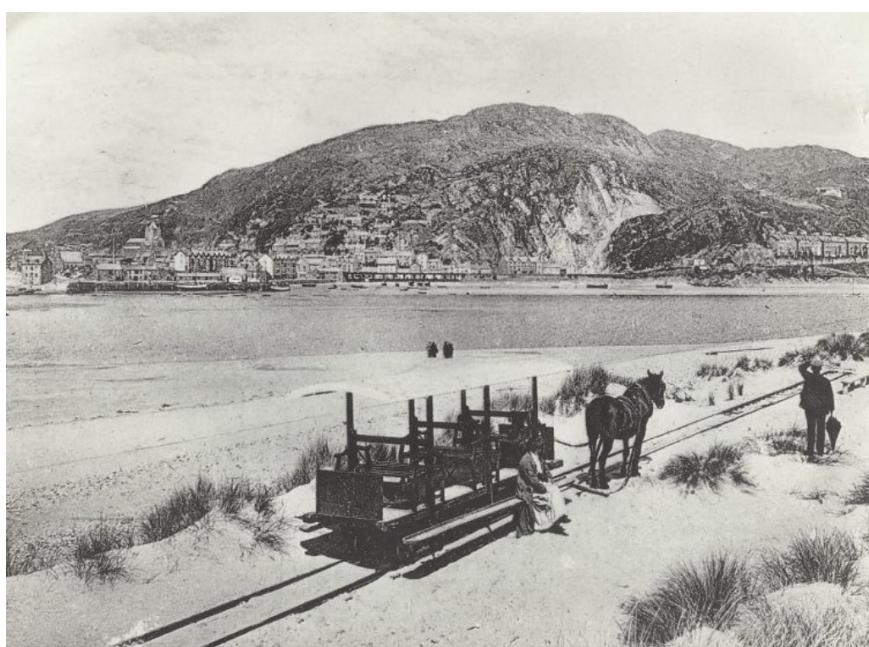
**Figure 13:**

Photograph from 1900, showing the horse drawn tramway built initially by Solomon Andrews during construction work at Fairbourne.

With the coming of the railways in Victorian times, holidays at the coast became increasingly possible and popular. The entrepreneur Solomon Andrews was developing holiday resorts around Cardigan Bay and purchased land at the mouth of the Mawddach estuary to establish the resort of Fairbourne. To facilitate construction work, he set up a network of horse drawn tramways. One of these ran along the coast and was adapted to carry passengers as a visitor attraction (fig.13). A similar line remains in use at the present day as the Fairbourne narrow gauge railway.

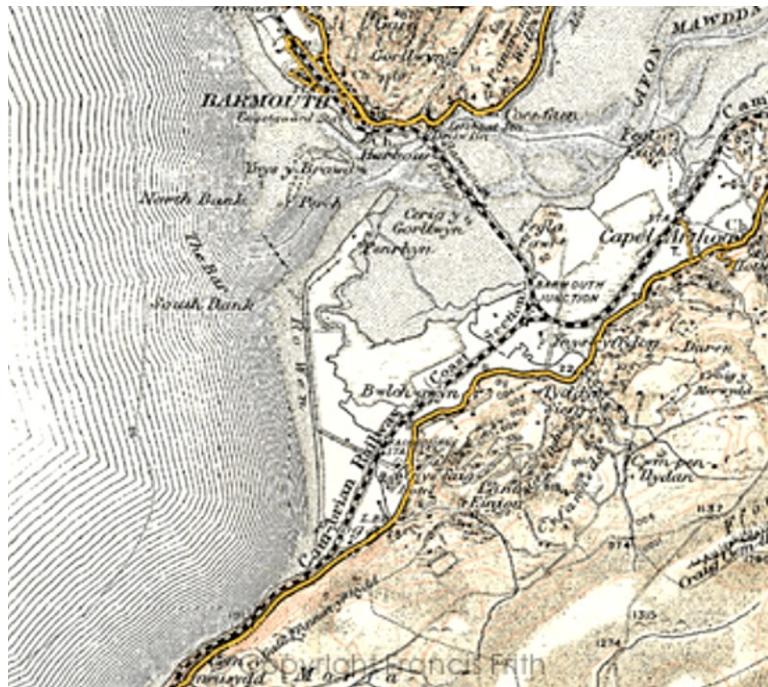
**Figure 14:**

Map of 1902, showing the shape of the Ro Wen shingle spit closely resembles its shape at the present day.

A map of 1902 (fig.14) shows the Ro Wen spit with a similar outline to the present day, except for a substantial accumulation of shingle which has subsequently occurred at the northern end of the spit.

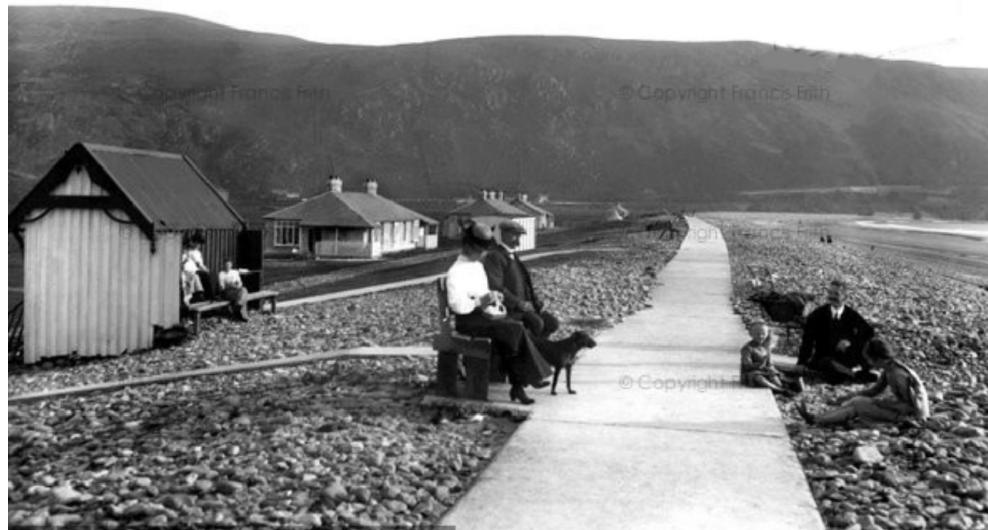
**Figure 15:**

Photograph about 1913 showing the sea wall constructed by Solomon Andrews to protect the newly established seaside resort of Fairbourne.

One of the works undertaken by Solomon Andrews was to excavate the crest of the shingle storm beach and emplace a concrete defence wall (fig.15).

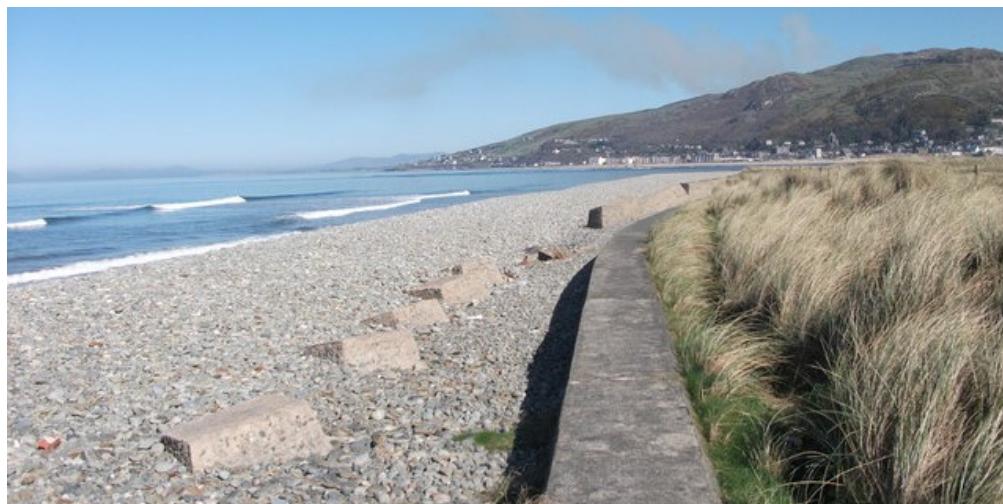
**Figure 19:**

The storm beach between Fairbourne golf course and the end of the Ro Wen spit. Notice how World War 2 concrete anti-tank defences have been almost buried by deposition of shingle in the intervening period.

Towards the northern end of the Ro Wen spit, there is evidence of substantial shingle accumulation over the period since the Second World War. Anti-tank defences have been buried by shingle to a depth of up to a metre (fig.19).

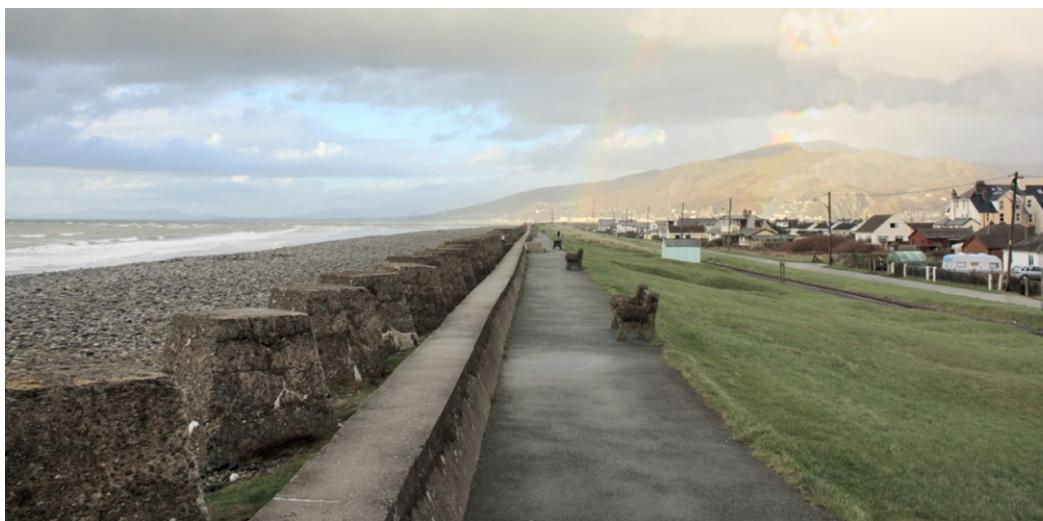
**Figure 20:**

The storm beach in front of Fairbourne village.  
World War 2 concrete anti-tank defences remain at their original height relative to the shingle, indicating stability of the storm beach at this location over the intervening period.

Similar concrete defences at Fairbourne village appear much as constructed, indicating stability of the shingle spit profile over the past half-century (fig.20).

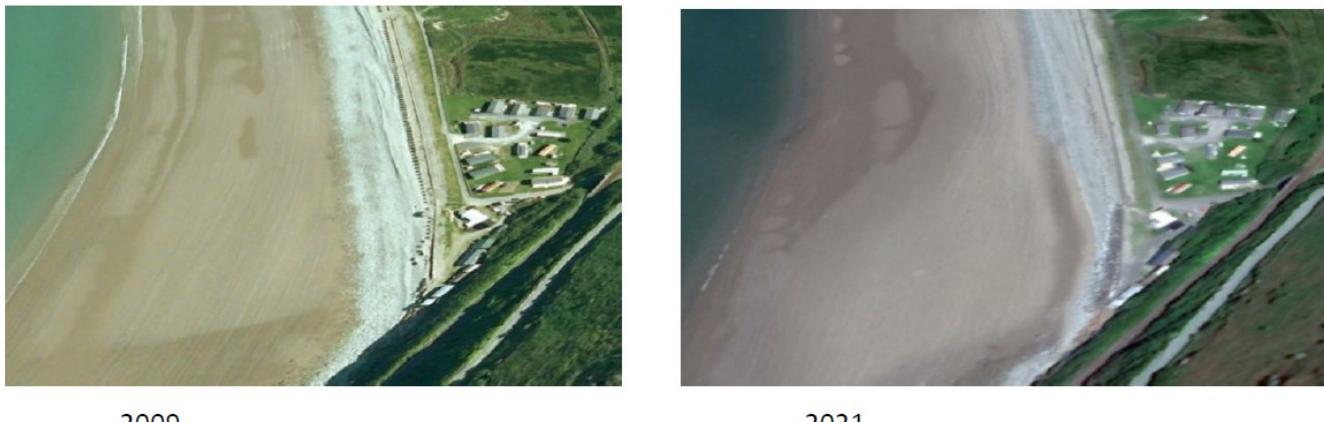
**Figure 21:** Comparison of the extent of storm beach deposits at Friog corner (Google Earth).

An area of concern in recent years has been the section of storm beach immediately adjacent to Friog cliff. Loss of shingle was recorded by Phillips (2017), and this is confirmed by comparison of air photographs (fig.21).

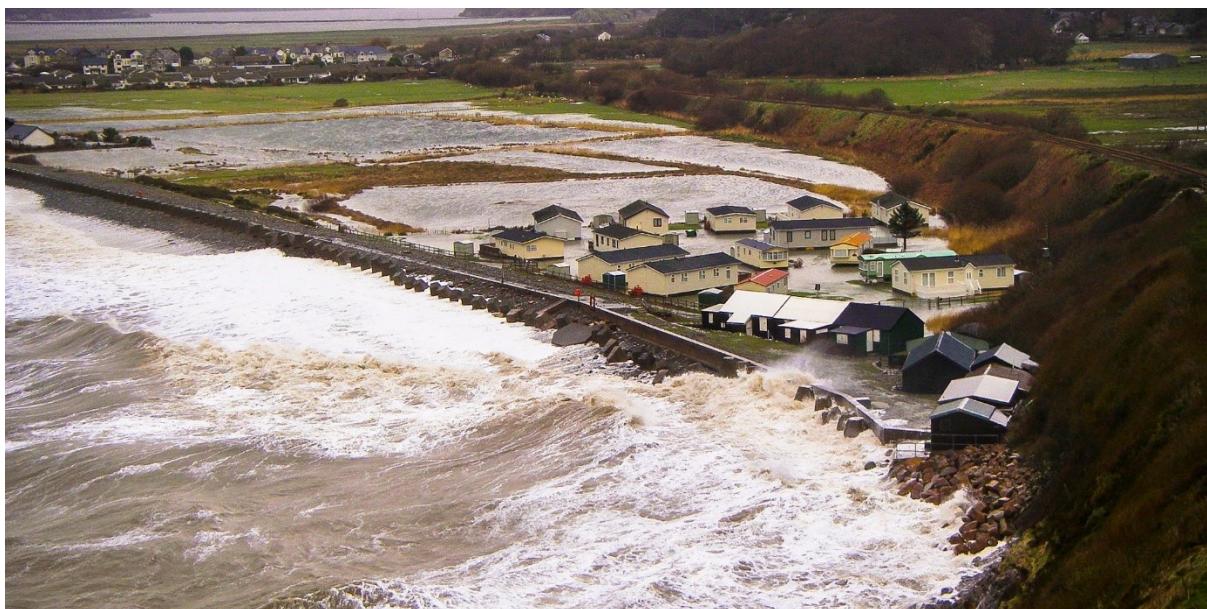
**Figure 22:** Failure of the eroded section of the Ro Wen shingle spit at Friog corner during a storm, causing localised flooding.

Erosion continued until failure of the sea defences occurred at Friog corner during a storm (fig.22). Wave action removed the small remaining amount of shingle from in front of the Solomon Andrews sea wall, which then fractured and allowed inflow of water. The Friog mobile home park was flooded to a shallow depth, along with neighbouring agricultural land, although Fairbourne village was unaffected.

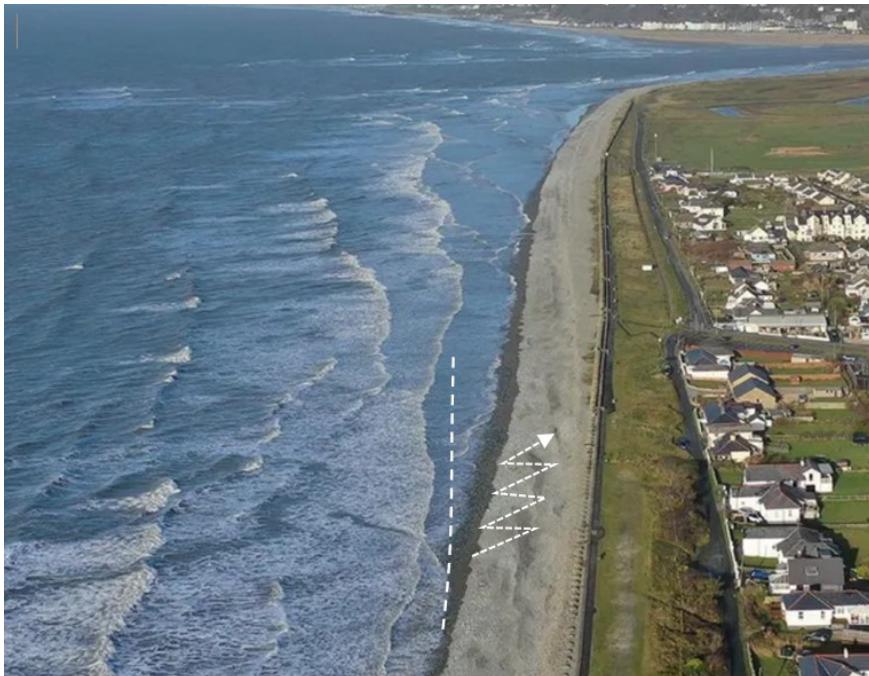
**Figure 23:**

Fairbourne. Long shore drift movement of beach sediment due to the oblique approach of waves to the shore.

The principal process which has created the Ro Wen spit is long-shore drift. This is the result of the oblique approach of waves, which is at approximately  $10^{\circ}$  to the line of the shingle spit for much of its length (fig.23). Breaking waves carry sediment up the beach in the direction of wave travel. Gravity return flow of the sea water then moves sediment back down the beach along a path at a right angle to the shoreline. Over a period of time, bulk transport of beach material occurs in a northerly direction.

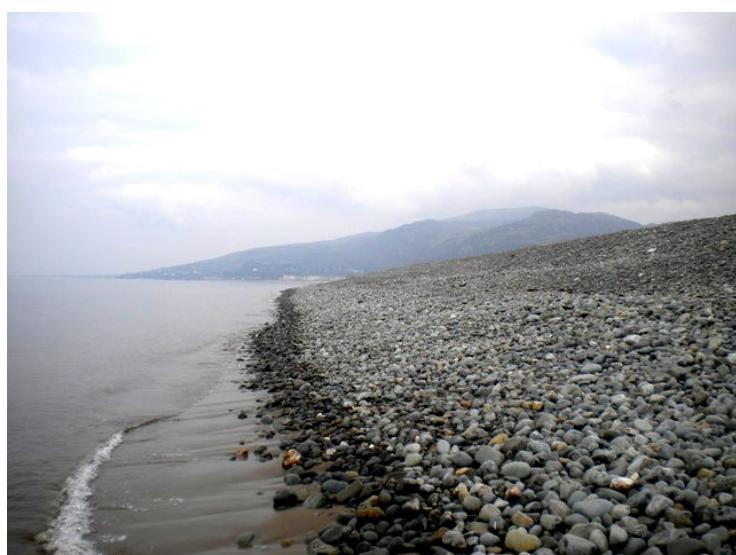
**Figure 24:**

Ro Wen shingle spit at calm water high tide. Notice that the tide just reaches the junction between the sandy foreshore and the base of the shingle storm beach.

The shingle storm beach of Ro Wen has developed above the level of normal spring high tide (fig.24). Below this level is a sand beach which is exposed at low tide (fig.25).

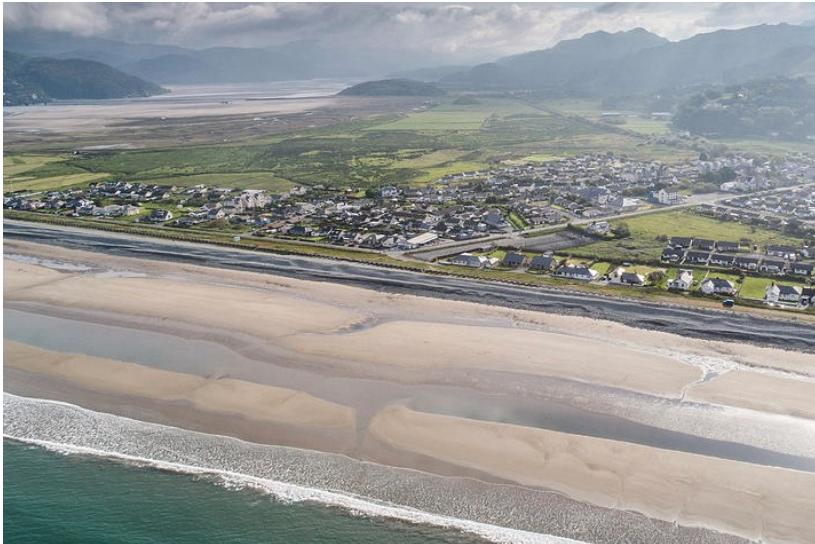
**Figure 25:**

Ro Wen spit at low tide. A berm runs parallel to the shore, separated from the beach by a trough.

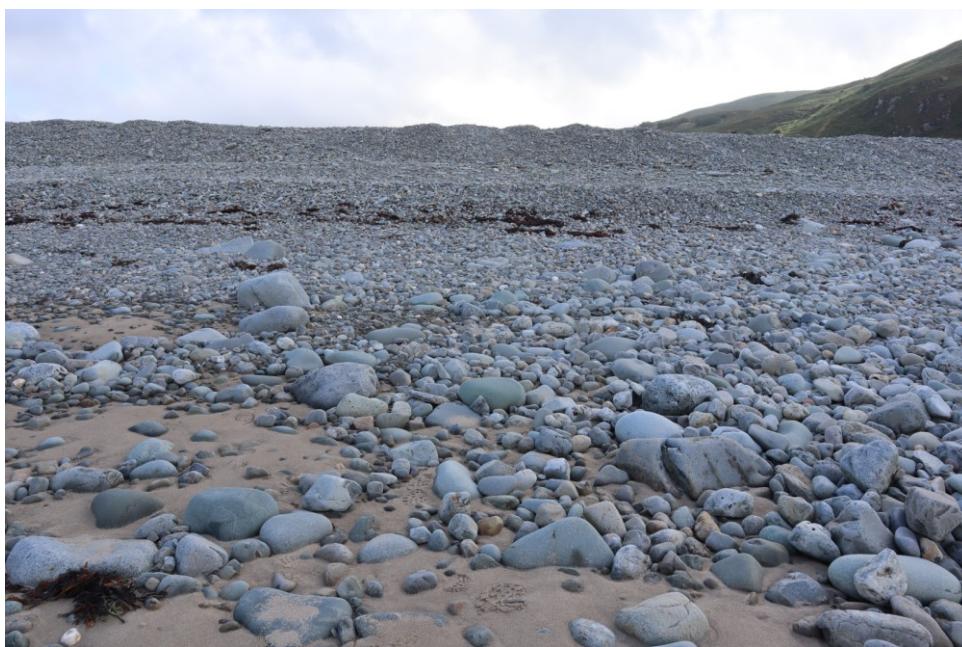
**Figure 28:**

Shingle storm beach near Friog, looking upwards from the sandy foreshore marking the level of calm water high spring tide.

The Ro Wen storm beach near Friog is shown in fig.28, looking from the edge of the sandy foreshore at the level of a calm high water spring tide. The shingle embankment extends to a height of 5.5m above the sand beach. This height is not by chance, but represents very closely the maximum height reached by breaking storm waves along this shore. The storm beach is a dynamic structure in equilibrium with marine processes. There is every indication that the height of the storm beach will adjust naturally to slow sea level rise over a number of decades, maintaining a height equal to maximum storm wave height. This will occur through storm waves throwing shingle onto the top of the existing structure if sea level rises and makes this possible.

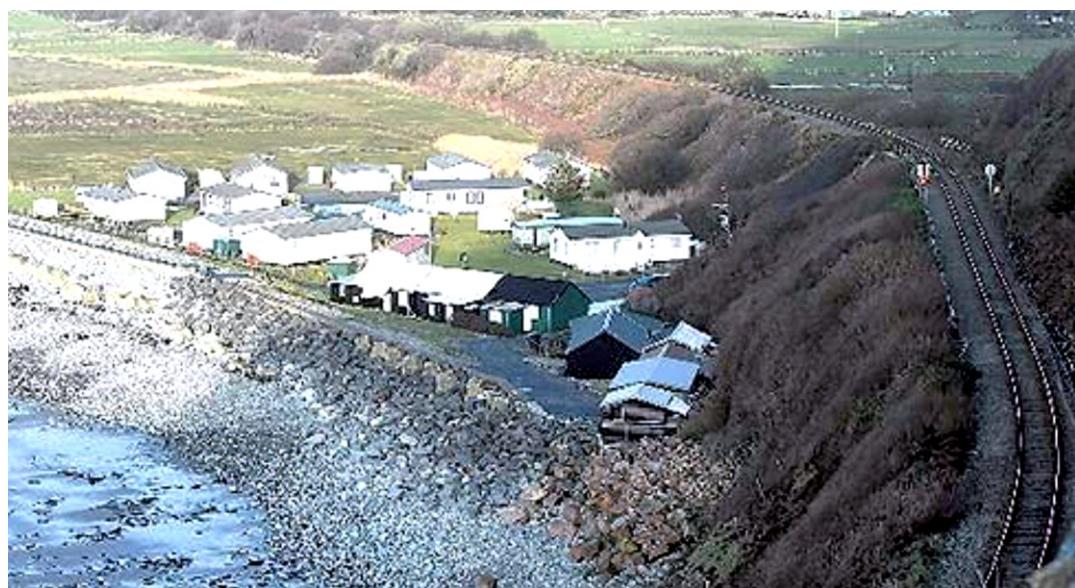
**Figure 30:**  
Shingle storm beach at Friog corner. This photograph was taken shortly before the sea wall failed during a storm.

The immediate cause of recent erosion at Friog corner was due to the angle of the storm beach face at this point, which was steeper than along the majority of the spit (fig.30). This favoured a plunging type of breaker, which caused further erosion until the concrete sea wall was exposed.

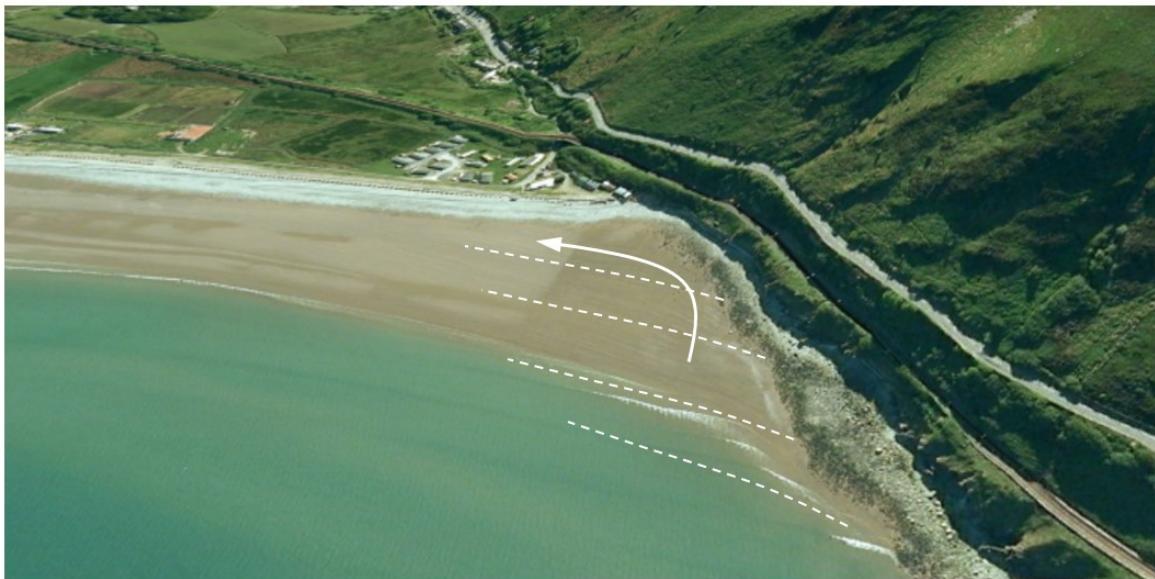
**Figure 33:** Approach of waves at Friog corner, and redirection of the water mass along the spit.

- Waves are refracted into the bay at Friog corner, approaching parallel to the shore. The water mass experiences a rapid change in direction northwards (fig.33). This creates a powerful current along the shore which carries smaller shingle towards Fairbourne, leaving only the larger and heavier material in situ.

- The removal of smaller shingle caused a steepening of the remaining storm beach at Friog corner. This favoured the plunging type of breaking waves, leading to further storm beach erosion. Eventually, the sea wall was exposed, and this fractured during a storm due to lack of structural support.

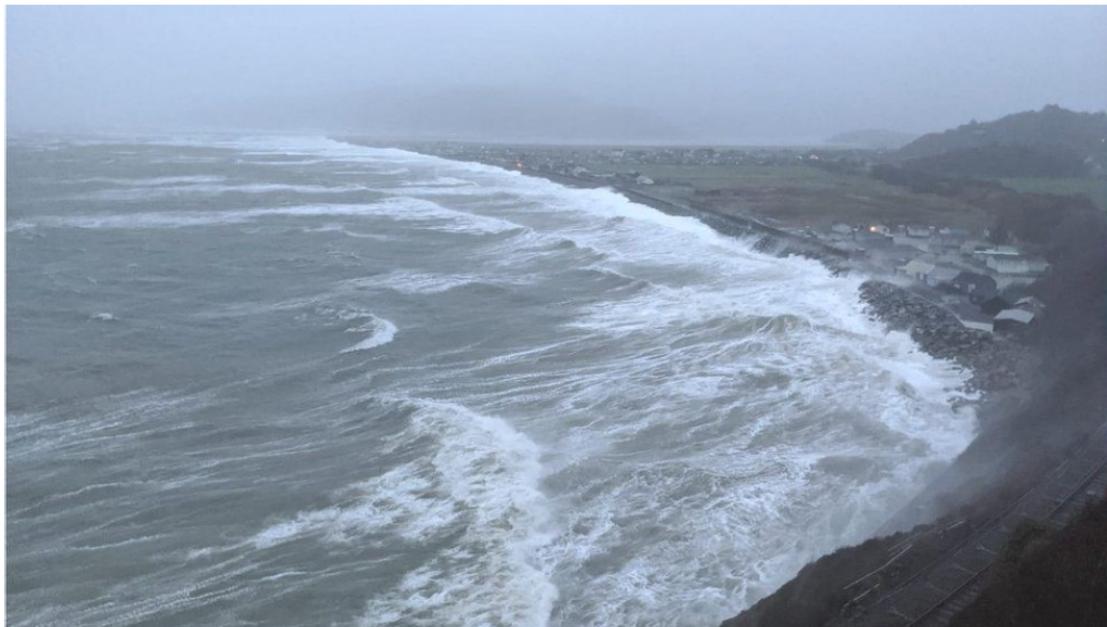
**Figure 34:** The Fairbourne coastline during Storm Clara, February 2020.

The Ro Wen spit has been observed during and after a series of severe storms over the period from 2020 to 2022 (fig.34). There has been no damage or erosion at any point due to storm waves, and no significant wave overtopping occurred. At no time was there any flooding in Fairbourne village or at the Friog mobile home park.

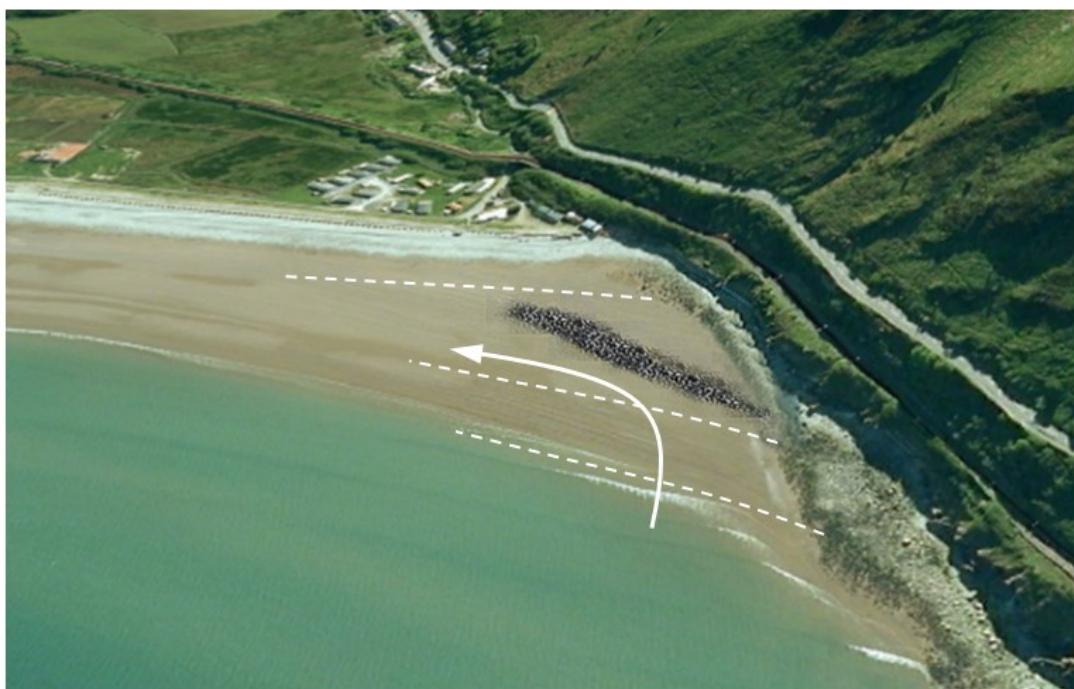
**Figure 35:** Proposed artificial reef to deflect storm waves at Friog corner.

A first step would be to prevent the direct impact of storm waves on the repaired sea wall, and to reduce the scouring action of storm waves as they are deflected towards Fairbourne. This can be done by the construction of a reef along the shore (fig.35). This might consist of boulders, concrete blocks, or other materials which would be stable against wave impact.

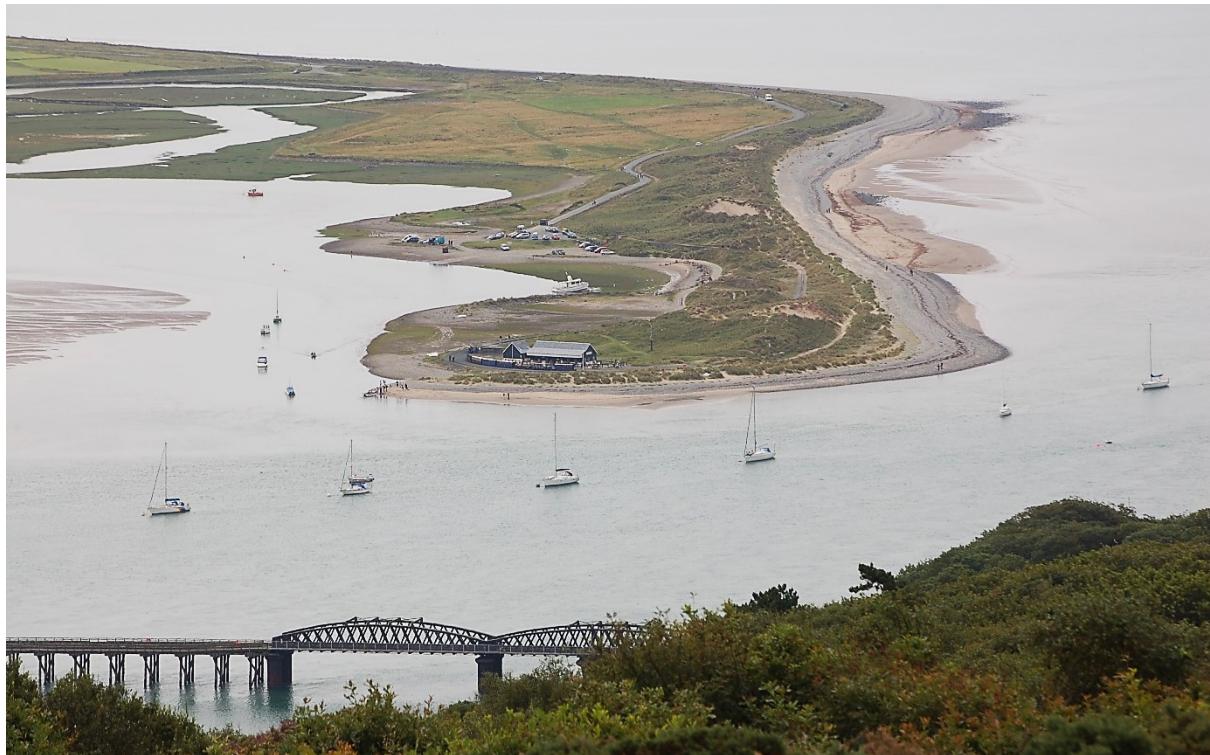
**Figure 36:** Northern end of the Ro Wen shingle spit. It appears that the large hooked end has been built up by shingle accumulation over the past century. Long shore drift carries sand and shingle along the spit to this point. Tidal currents can transport sand into and then out of the Mawddach estuary, allowing it to continue on a northwards passage to Barmouth beach. However, the tidal currents are not sufficiently powerful to transport shingle, which accumulates around the end of the spit.

A sheltered section of beach will be created behind the reef. It is recommended that shingle is brought from the northern end of the Ro Wen spit (fig.36) and deposited in this area, where wave action will carry it onto the shore and build up a new storm beach against and above the rock armour of the repaired sea wall. It is likely that any shingle removed from the end of the spit will be replaced naturally by longshore drift.

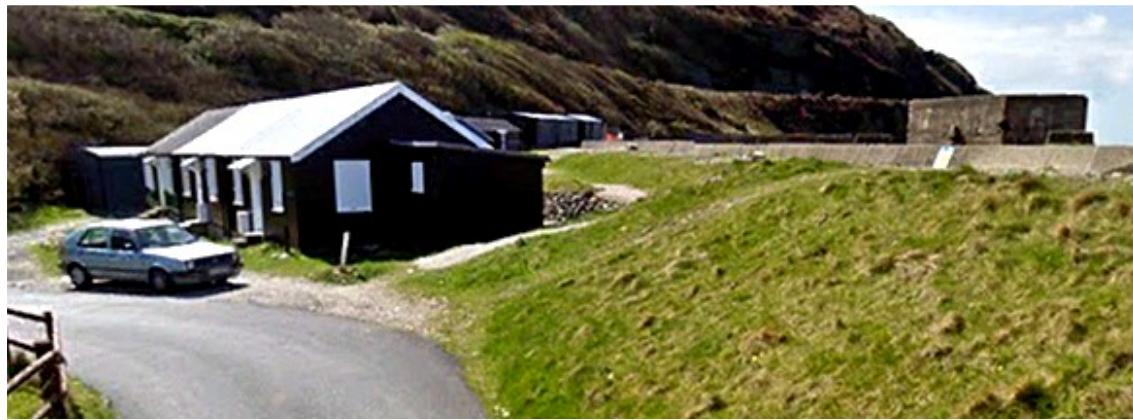
**Figure 37a:** Current position of huts at Friog corner. The excavation to produce level ground can be seen behind the huts.

Urgent attention should be given to restoring the landward profile of the storm beach at Friog corner, to provide mechanical support to the sea wall when impacted by storm waves. It is recommended that the huts at this point are relocated further from the sea wall (fig.37), and the landward slope built up with rock material. Slate waste, available locally, would be suitable for this purpose as it contains a large amount of clay which would prevent any infiltration of sea water beneath the sea wall during high storm tides.

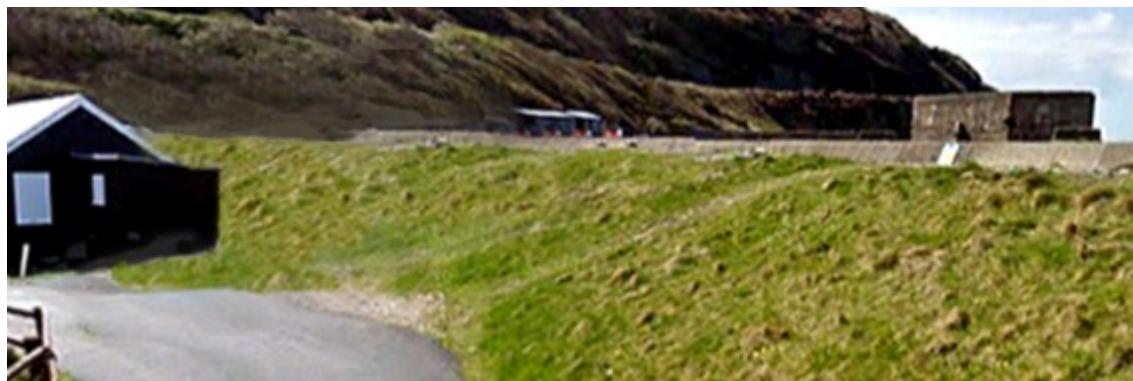
**Figure 37b:** Suggested relocation of the huts further from the sea wall, with restoration of a substantial embankment to provide support for the concrete wall.

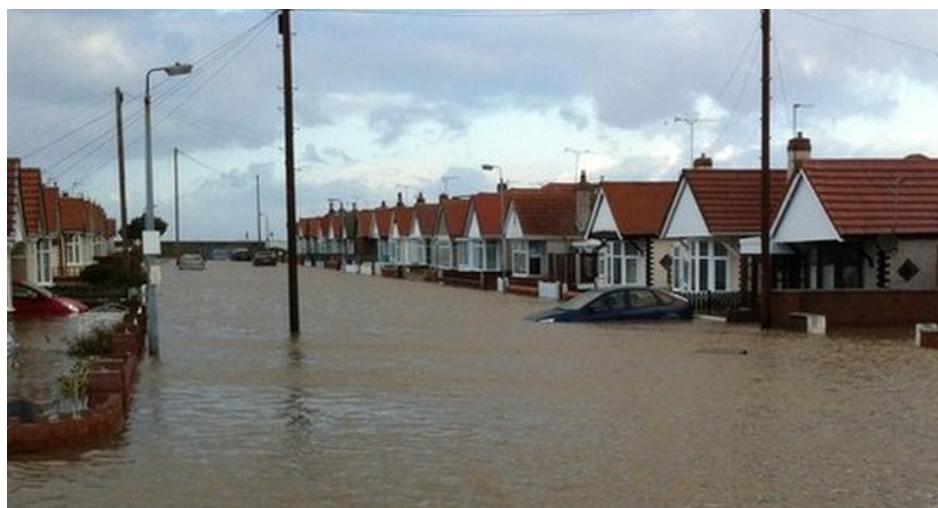
**Figure 39:**  
Flooding at Towyn.

In both cases, the village is shown as flooded to a depth of around 0.45m, which is about knee deep. This is similar to flooding which occurred in Towyn, near Abergele (fig.39).

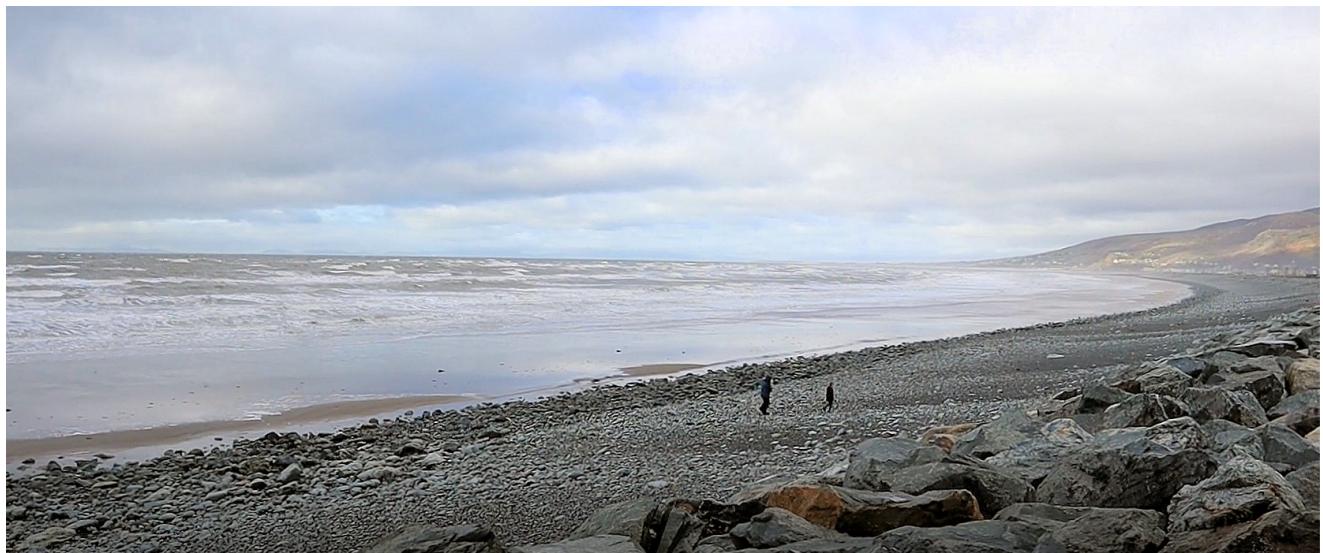
**Figure 40:** Fairbourne beach and Friog sea defences a few hours after Storm Eunice, February 2022.

Major storms have actually occurred in North Wales during the period specified for the models. Storm Clara in February 2020 and Storm Eunice in February 2022 both caused extensive flooding and damage to property across North Wales. These storms were at the limit of storm magnitude possible for the Welsh coast, taking into account the geometrical configuration of the Irish Sea basin and the maximum wind force produced in the Atlantic. They therefore count as close to 100 year events. **However, no flooding at all occurred in Fairbourne during either storm, and no damage was done to any of the sea defences (fig.40). Both flood models are totally in error, and have clearly been based on invalid assumptions or data.**

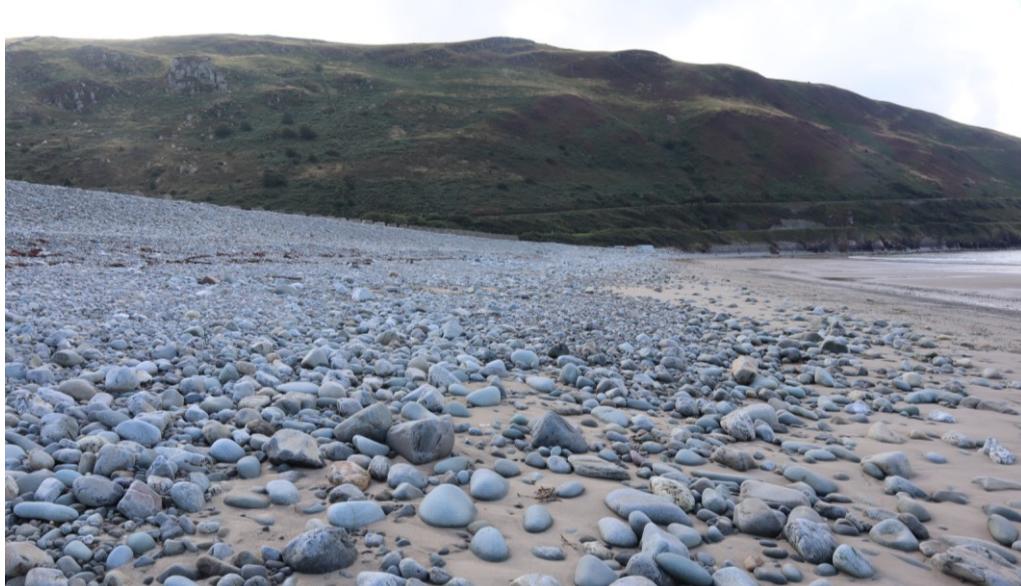
**Figure 42:**

Sequence of images across the Ro Wen spit. The foreground represents the location of the simulated breach of the storm beach.

(a) beach and face of the storm beach.

The sequence of photographs in fig.42 show the line of the simulated breach. Data collected by M. Phillips (fig.18) indicates that the storm beach in this location has a volume of approximately 400 cubic metres of shingle per metre along the spit. Additionally, a concrete wall has been emplaced along the centre of the structure, approximately a metre in thickness and extending to a depth of about 3 metres.

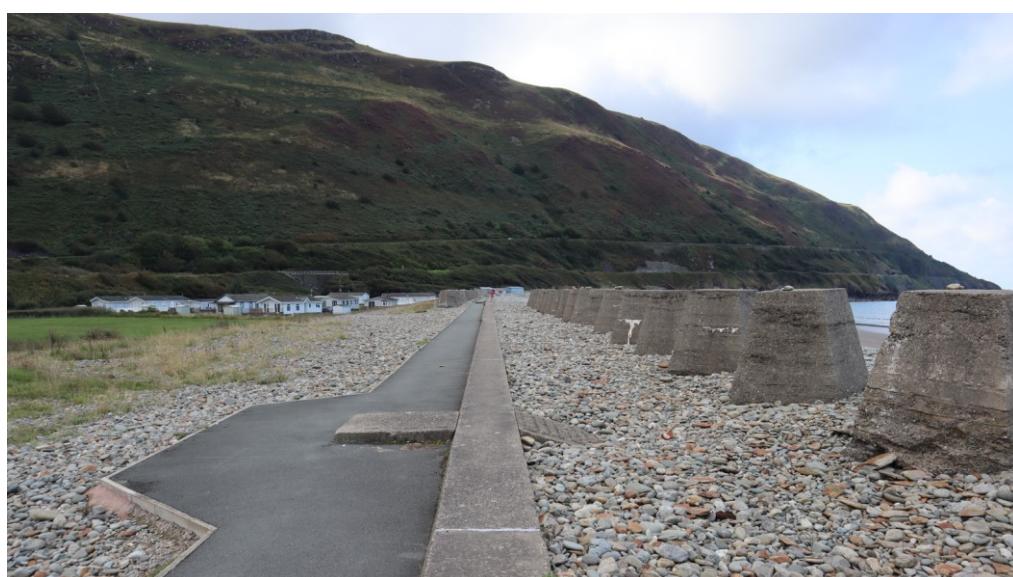
(b) upper surface of the storm beach

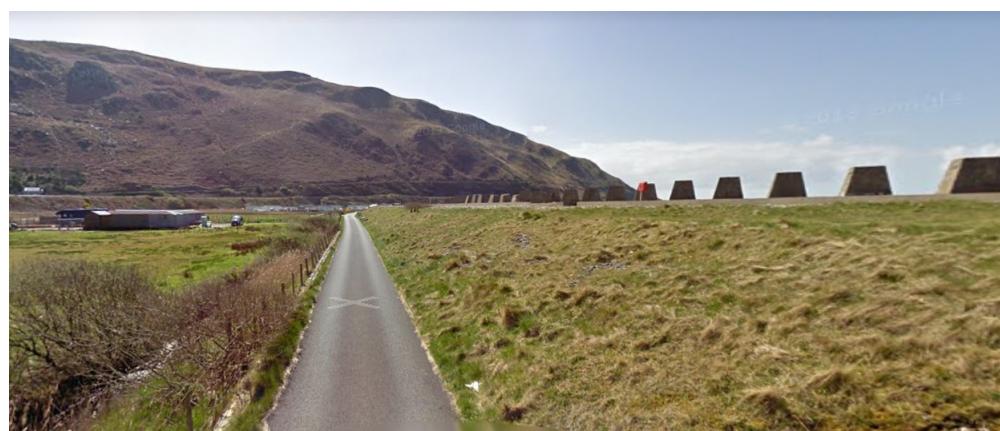
(c) landward slope of the storm beach

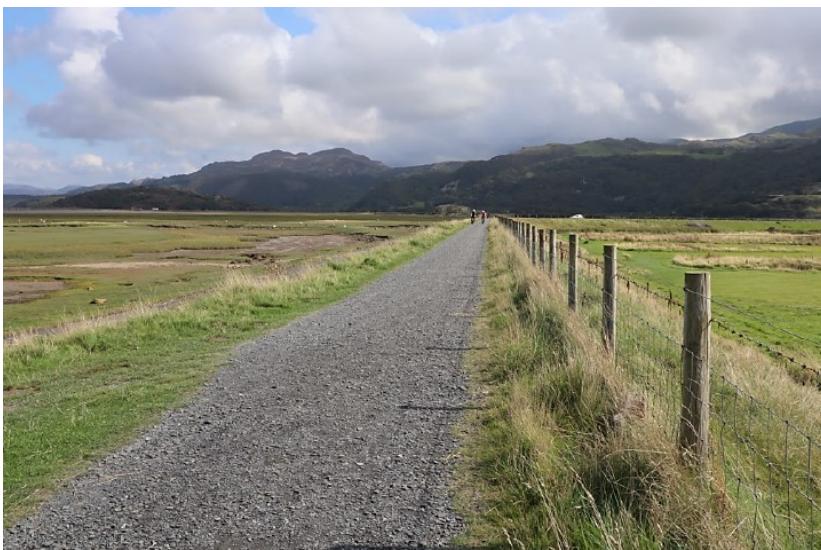
**Figure 48:**

Estuary flood protection embankment north of Fairbourne (shown as C in fig.47 above).

- The height of the estuary flood defence embankment would be raised by 1 metre to prevent overtopping under storm surge conditions and sea level rise. There is no current urgency as the estuary embankment is providing adequate protection at the present day (fig.48). This work could be carried out over the period between 2040 and 2060. The embankment lies at the head of a wide area of salt marsh which effectively dissipates wave energy, so it would be safe to raise the embankment level by the simple addition of slate waste or clay and sand materials. If the proposed new embankment has been constructed to the east of Fairbourne, only the short section of estuary embankment north of the village would need to be raised (shown as C in fig.47).

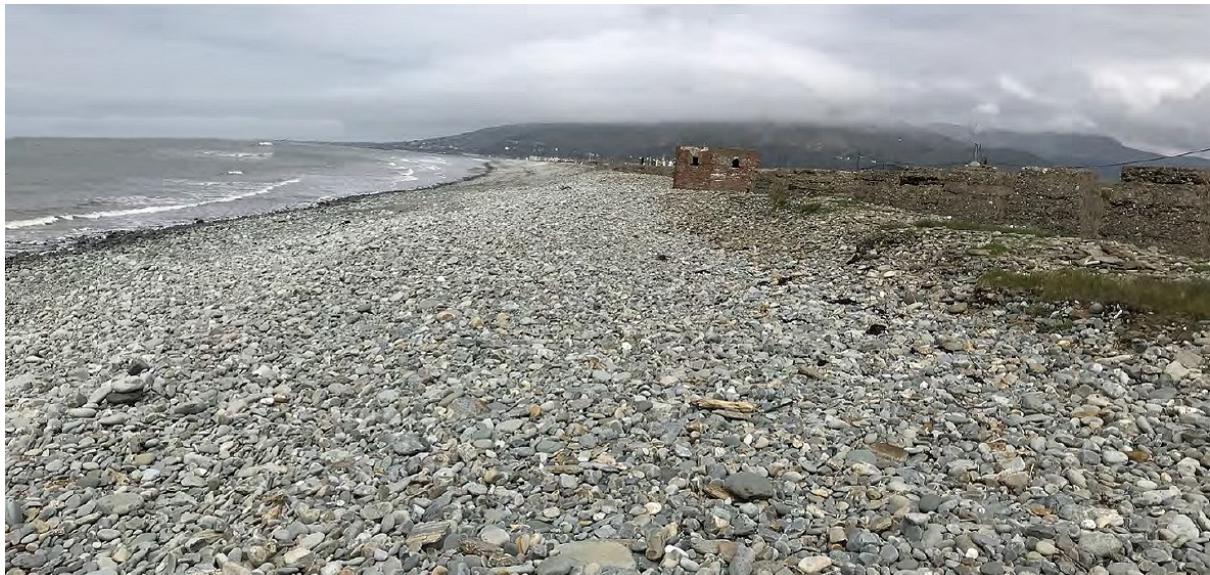
**Figure 49:** Upper surface of the storm beach, showing the accumulation of shingle thrown up by storm waves.
