Investigating flood protection for North Barmouth

Graham Hall, PhD, FGS, C.Math June 2026

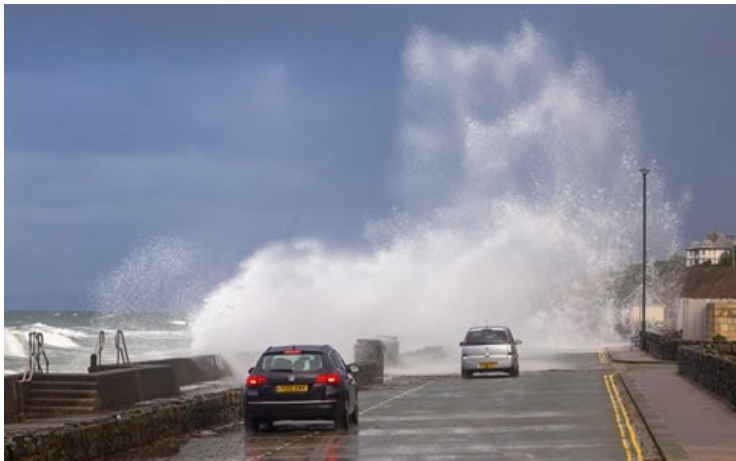
Figure 1:

Wave overtopping of the sea wall during Storm Amy, 2025

Improved coastal protection is welcomed by local residents and businesses, who have seen storm waves overtopping the promenade sea wall during winter storms in recent years.

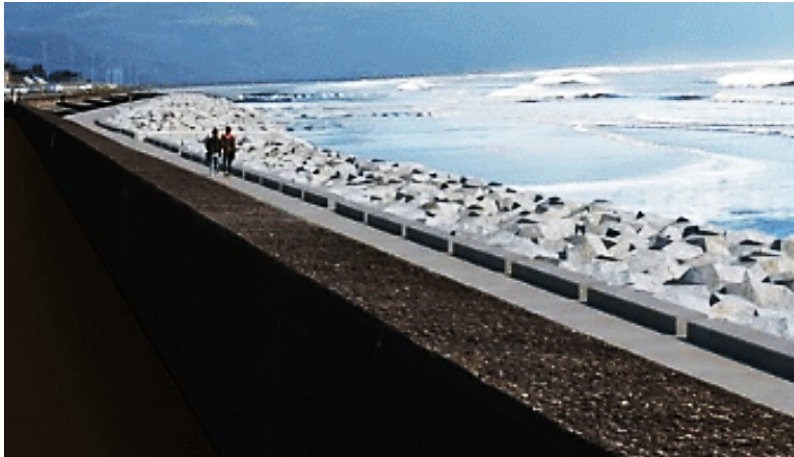
Figure 3:

Artist's impression of the rock armour and pedestrian walkway in front of the existing promenade.

The first component of the proposed Gwynedd Council scheme is rock armour consisting of large boulders which will be placed along a 1 km length of the sea wall in North Barmouth, as shown in Fig. 3. This appears to be combined with a new pedestrian walkway built in front of the existing sea wall.

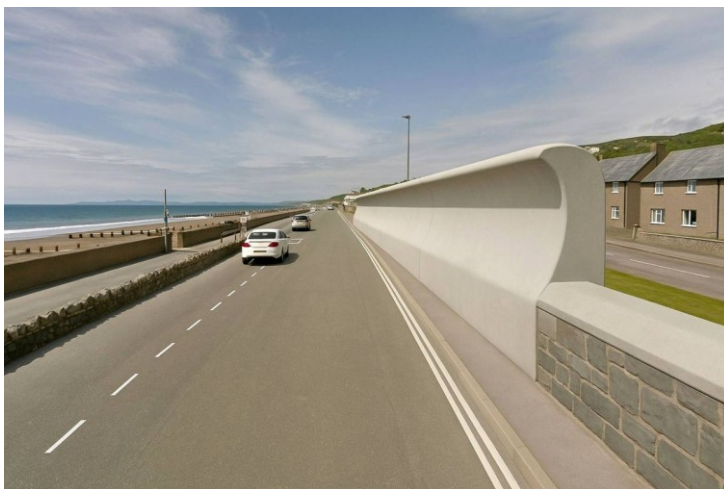
Figure 4:

Artist's impression of the proposed wave deflection wall inland of the promenade road.

The second major component is a concrete wall, approximately 1.5 metres in height, on the landward side of the promenade road. The wall will have a recurved section intended to deflect breaking waves during a storm, as shown in Fig. 4. The wall will run for a distance of a little over 1 km.

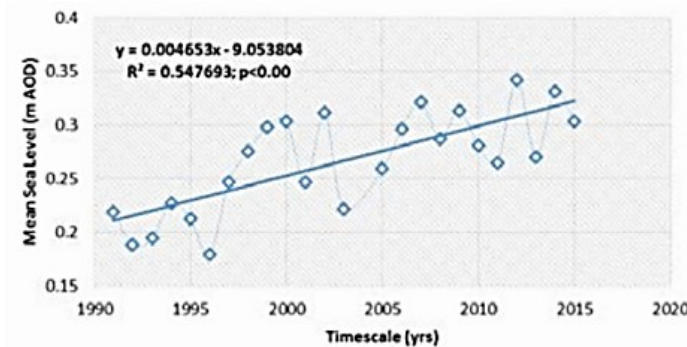
Figure 5.
Average sea levels recorded at Barmouth railway bridge.

Research was carried out by Phillips, Thomas and Morgan (2017) to investigate sea level rise at Barmouth, using data from the tidal gauge at Barmouth Railway Bridge. It was found that in the 25 year period between 1990 and 2015, astronomical tide level rose by approximately 10 cm.

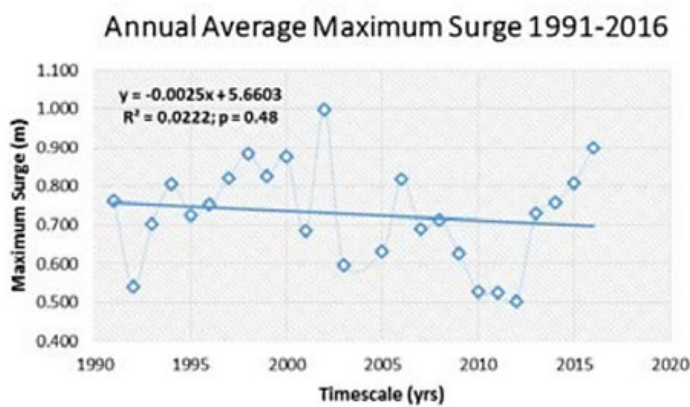
Figure 6.
Maximum storm surges recorded at Barmouth railway bridge.

The additional heights caused by storm surges and by wind generated waves do not appear to have increased over the 25 year period. This seems reasonable, since these phenomena are controlled by the shape of the Irish Sea basin, and by the maximum wind speeds over Cardigan Bay which have not changed significantly during this period.

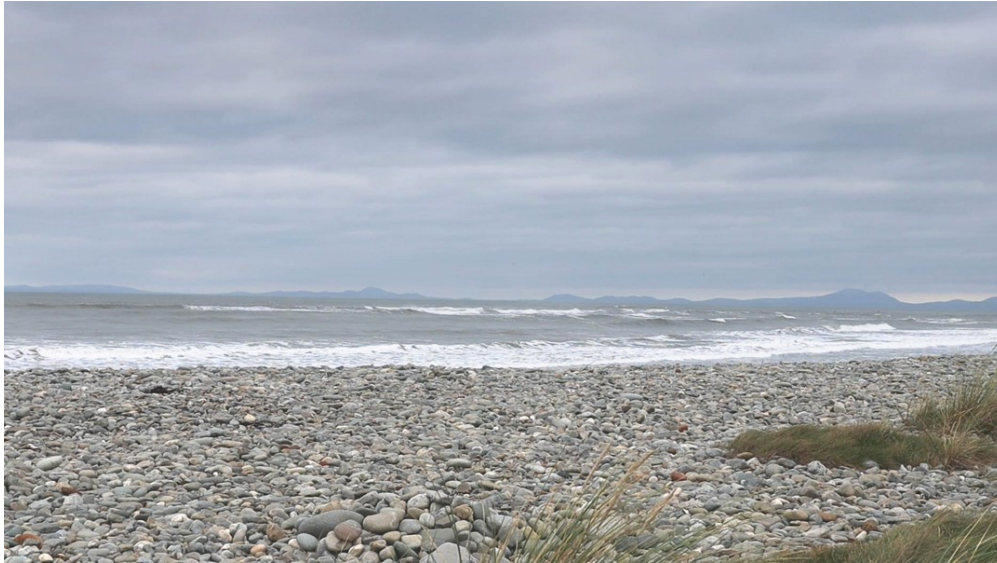
Figure 12. View from the shingle spit at the mouth of the Mawddach estuary. Waves are breaking on sand banks in the middle distance.

Looking from the end of the Ro Wen shingle spit at the estuary mouth, the sand banks are marked by a line of breaking waves some distance from the shore (Fig. 12).

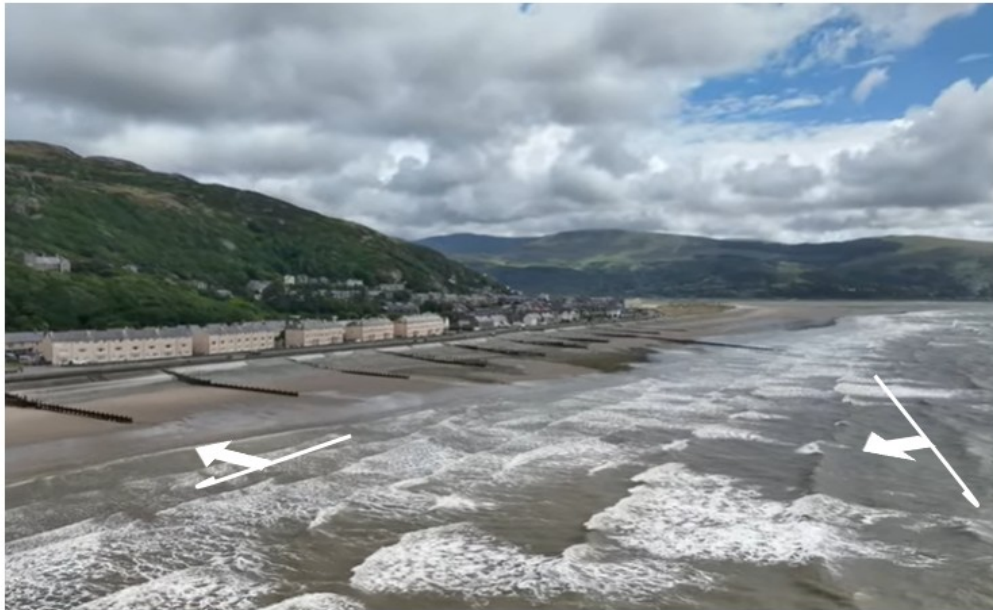
Figure 14. Waves approaching Barmouth from the south west are slowed as they enter the shallow coastal water and swing around to approach the beach more directly towards the sea wall.

Upon entering the nearshore, refraction of waves occurs over the shore platform. It is seen that waves swing around to approach the shore more directly (Fig. 14)

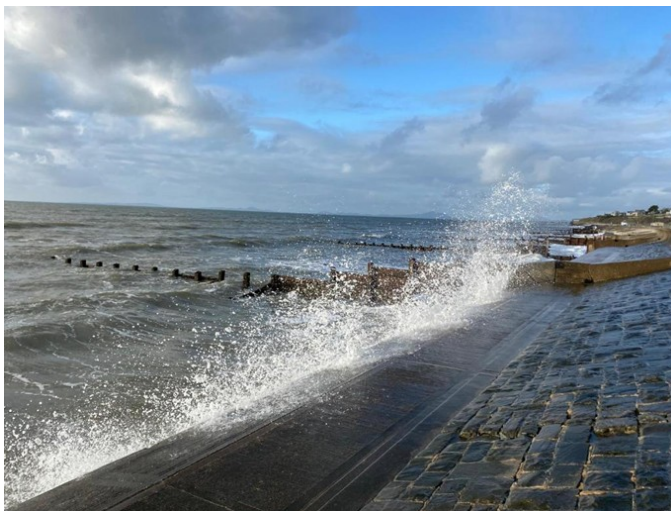
Figure 17.

Wave breaking against the wall at the base of the sea wall slope under low tide conditions.

Out shore transport occurs when waves break against the lower face of the sea wall slope under low tide conditions. Water is reflected back seawards, carrying sand with it. In places this is exposing the base of the sea wall and a line of sheet steel piles which had been emplaced to protect the structure. The steel piles are showing evidence of corrosion.

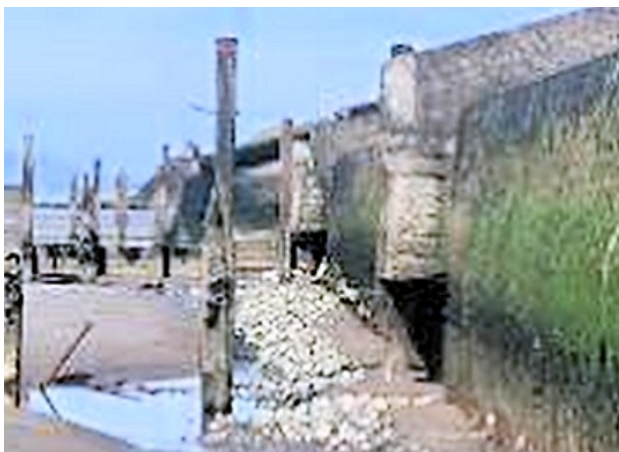
Figure 18.

Evidence of beach loss at the base of the sea wall due to erosion by reflected waves.

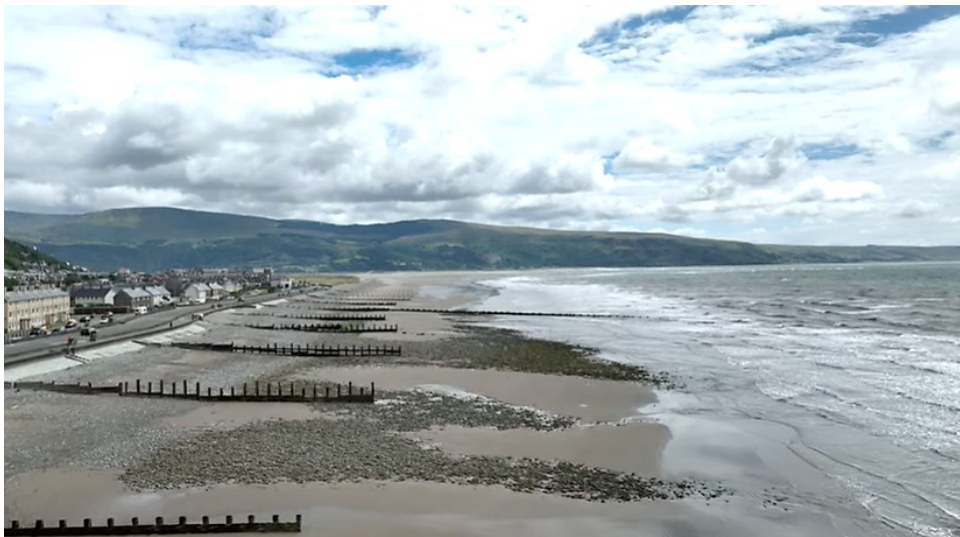
Figure 19. Areas of exposed coarse glacial deposits exposed on the lower beach at low tide.

Erosion by outflowing reflected waves has caused scour at lower levels of the beach, exposing areas of coarser glacial deposits.

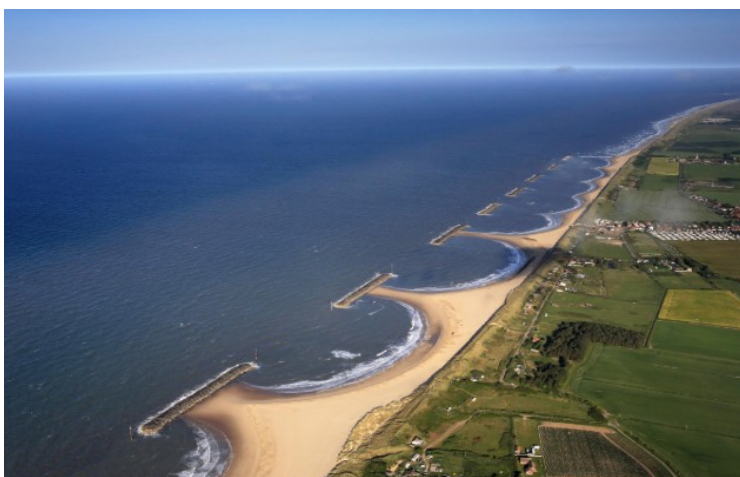
Figure 20.

Near shore reefs at Sea Palling, Norfolk, leading to the growth of sand banks which will gradually coalesce to fill the embayments between the reefs.

Near shore reefs have been used to regenerate beaches in many parts of the world, with successful schemes carried out in recent years in Florida, U.S.A and the Gold Coast of Australia. In Britain, a near shore reef system has been built at Sea Palling in Norfolk.

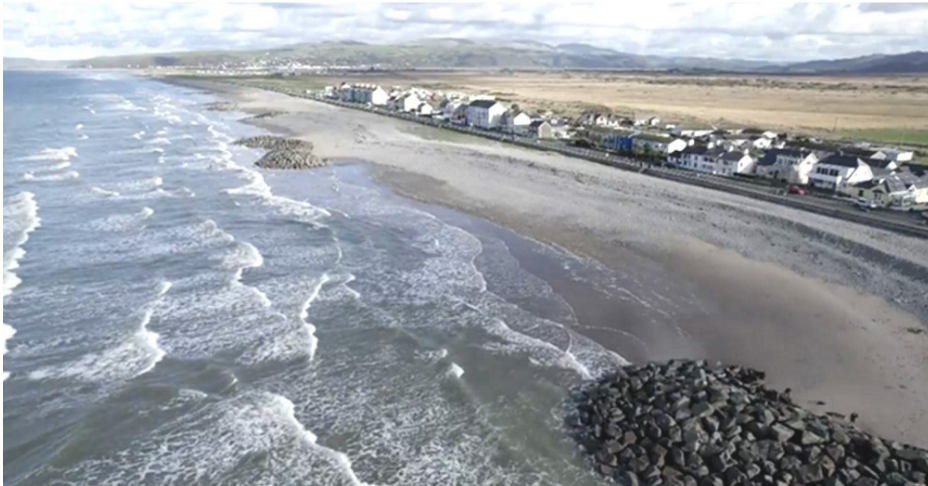
Figure 21. Boulder reefs placed on the beach at Borth.

This technique has been used successfully in Borth (fig.21). It can be seen that sand and shingle is now accumulating naturally behind the reefs.

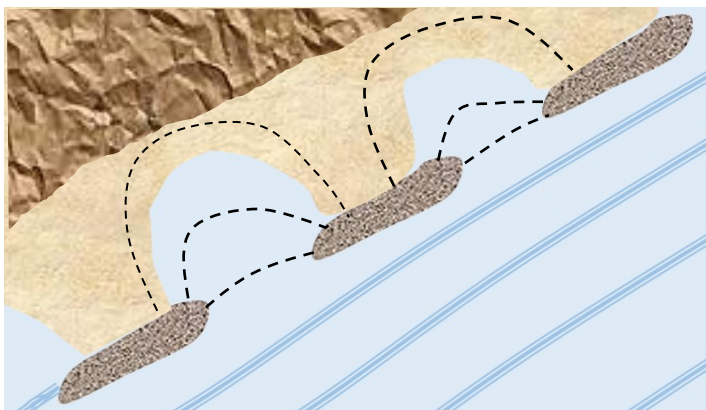
Figure 22b.

Over a period of time, sediment gradually accumulates behind the reefs then fills the embayment between reefs.

Sediment accumulates behind the reefs, linking them to the shore in a feature known as a 'tombolo'. Over a period of time, sediment fills the embayment between reefs to ultimately produce a linear beach margin corresponding with the reef line (Fig. 22b).

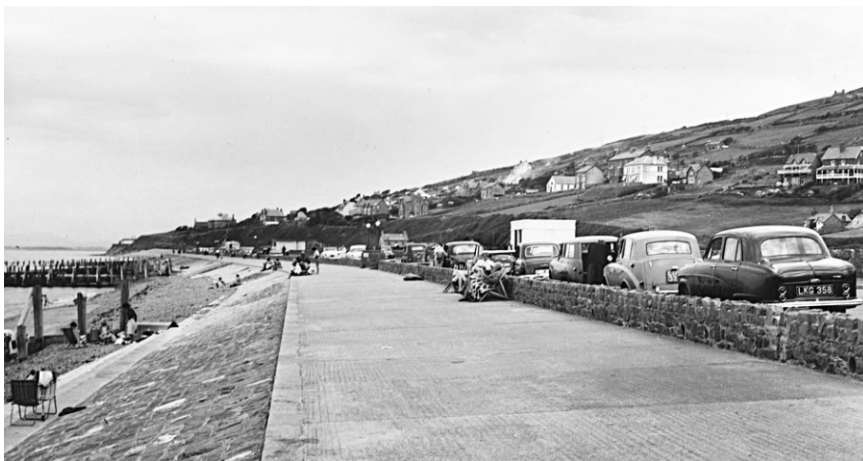
Figure 24.

North Barmouth promenade and sea wall as originally constructed.

The present day sea wall in North Barmouth was constructed in the 1920's. When first built, this consisted of a flat promenade of concrete slabs, flanked by a slope of concrete panels faced with stone blocks. The slope ended at the level of the beach. Holiday makers had open access to the beach down steps, ramps, or the sloping wall (Fig. 24).

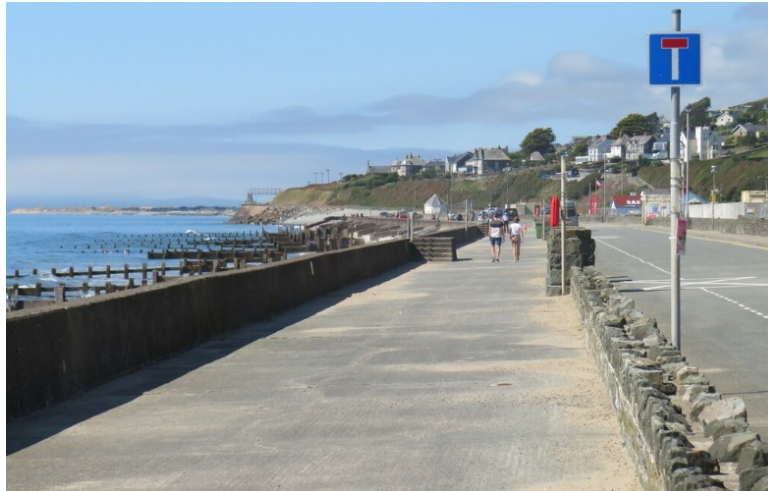
Figure 25.
North Barmouth promenade after addition of the vertical wall to prevent wave overtopping.

A significant change to the promenade was the later addition of a vertical wall at the head of the sloping panels (Fig. 25). It is likely that beach erosion had begun. Approaching waves were losing less of their energy in running up the shallow sloping sand. Waves could reach the sea wall with sufficient energy to break and overtop the edge of the promenade, causing flood water to flow across the walkway. The new vertical wall was no doubt intended to prevent wave overtopping.

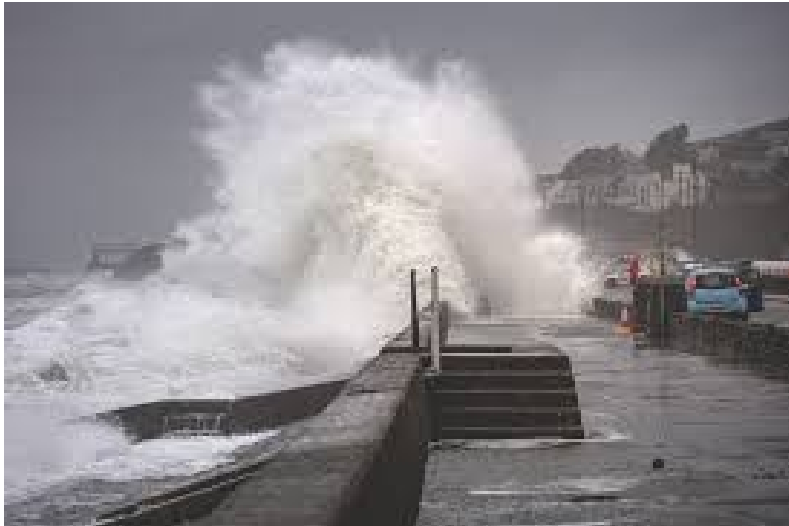
Figure 27.

Storm wave breaking against the North Barmouth sea wall.

The promenade in North Barmouth during storm conditions is shown in Fig.27 below. It is important to note that sea level was around four metres below the top of the sea wall. The huge cloud of spray was produced by the dissipation of energy as a wave ran up the sloping base and broke directly against the vertical wall. This impact can be damaging. Cracks can develop in the concrete due to the impact of waves against the flat face of the wall.

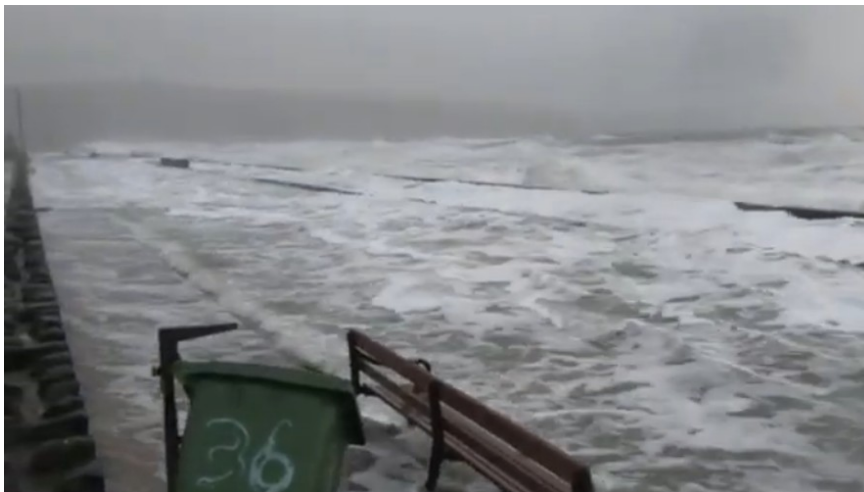
Figure 28. North Barmouth promenade under extreme storm conditions during a high tide combined with a storm surge.

Fig. 28 below shows the situation during an extreme storm of the magnitude expected once a year. A high tide is augmented by a storm surge and wind generated waves, such that the level of the sea is close to the top of the sea wall. Notice that there is relatively little wave impact with the wall and only small amounts of vertical spray are produced. Water simply overtops the wall as a surface flow.

Due to the seawards slope of the promenade and road, the overtopping water barely reaches the foot of the inland wall.

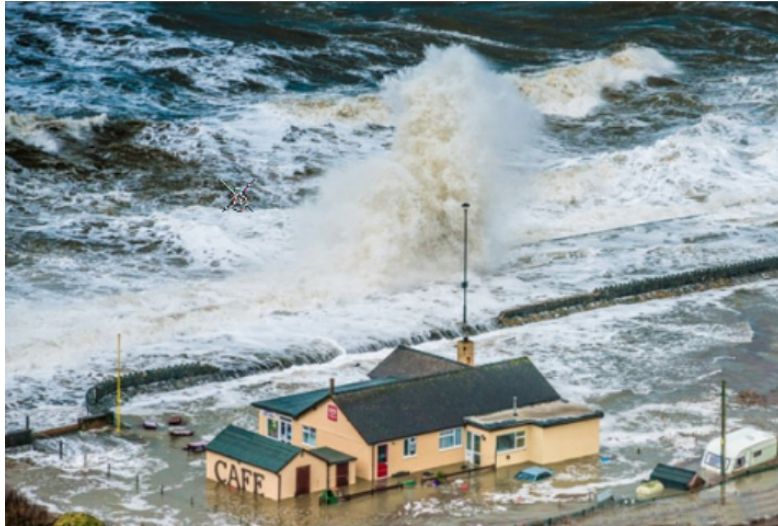
Figure 29.

2014 storm surge and strong waves causing flooding at the café at the north end of the shore road.

Fig. 29 shows flooding which occurred at the café at the north end of the shore road during a major storm event in 2014. This is close to the point where wave damage during a different storm caused the collapse of a section of the sea wall (fig. 2). Additional height appears necessary for the primary or secondary wall in this location.

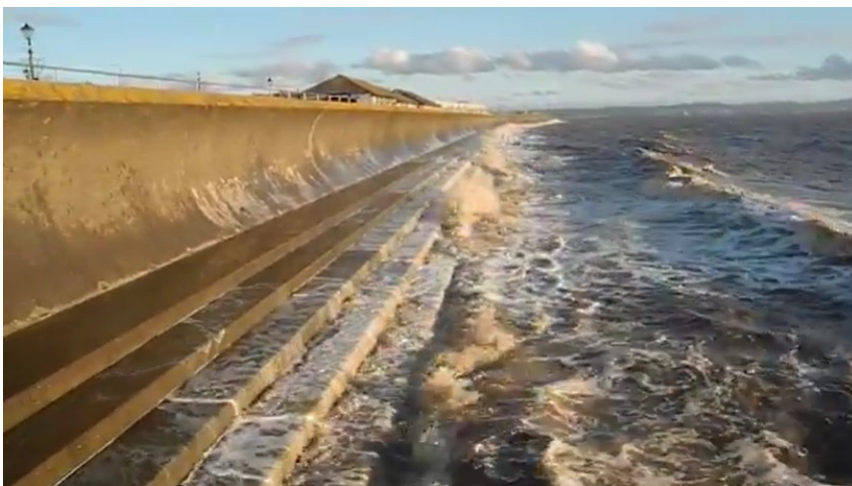
Figure 30.

Sea wall with a recurved profile to the upper section. Burnham on Sea, Somerset.

It has been shown that the damaging impacts caused by waves hitting a vertical sea wall can be reduced by incorporating a recurved profile, as at Burnham on Sea (fig. 30).

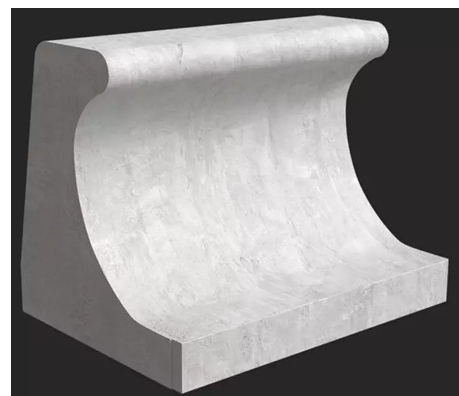
Figure 31. Prefabrication of reinforced concrete recurved sea wall panels for installation on site.

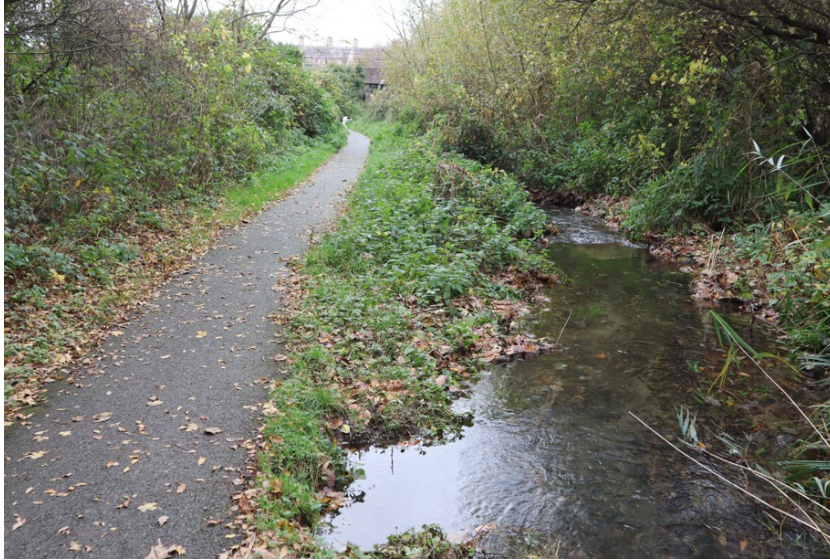
Figure 32.

Stream crossing the lowland area north of the football ground.

The principal line of drainage in North Barmouth is a small stream which descends from the hillside of Craig y Gigfran, then crosses the lowland to the north of the football ground (Fig. 32).

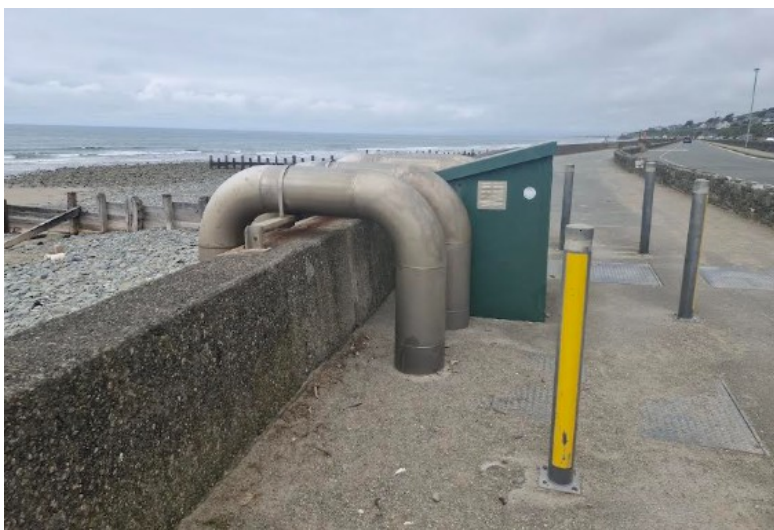
Figure 33.

Drainage pump installation on the promenade, located at the mouth of the small stream in North Barmouth.

At low tide, the stream discharges into the sea through a tidal gate at the sea wall. At high tide, gravity outflow is prevented. Electric pumps installed on the promenade lift the drainage water over the sea wall (Fig.33).

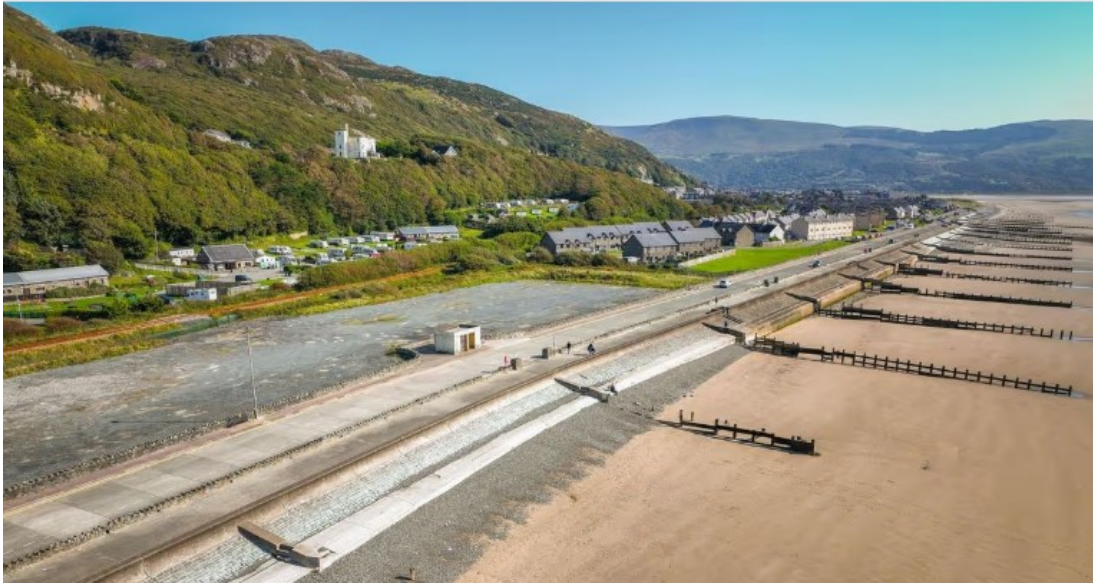
Figure 34. Area of currently unused land in North Barmouth which could provide a flood water retention lake.

A substantial area of land adjacent to the north promenade road is not currently in use (fig. 34). This provides an opportunity for developing a retention lake to receive and store overtopping wave water and hillslope runoff during a storm. This water can then be discharged into the sea by pumping or by gravity flow at low tide.
